# Spinal fractures from high-speed powerboating

**Vertebral compression fractures are a risk in high-speed boating and should be considered in a patient presenting with back pain after having been adventure jet boating.**

MedicineToday 2011; 12(6): 82-83

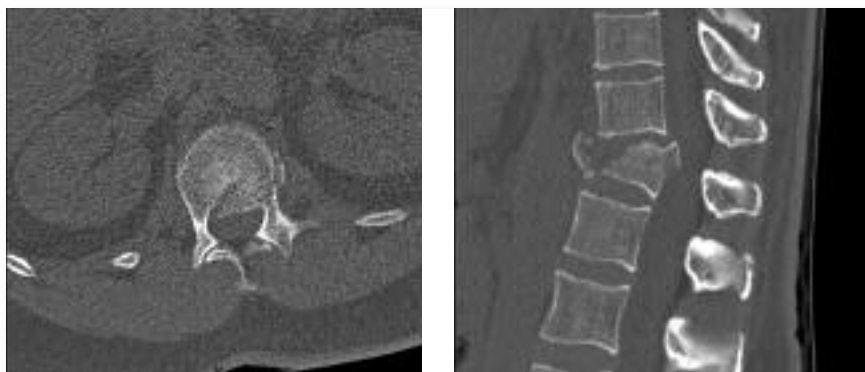
Figure 1. Case 1. CT showing the T11 unstable fracture require a pedicle screw. a (left). Axial section. b (right). Sagittal section.

gave her analgesia (methoxyflurane inhalation), checked her vital signs (all normal, including cardiac rhythm strip) and also noted no major neurological abnormalities. Using spinal precautions because of the history and thoracolumbar pain, they brought her to the emergency department. CT of her back showed a burst fracture of T11 that was unstable (Figures 1 and 2). She required neurosurgery – a T10 to T11 pedicle screw to stabilise the spine.

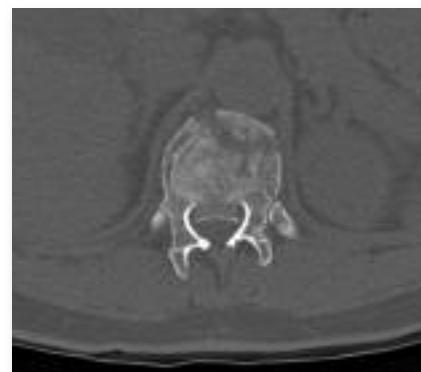
Figure 2. Case 1. CT, axial section, showing the T11 burst fracture.

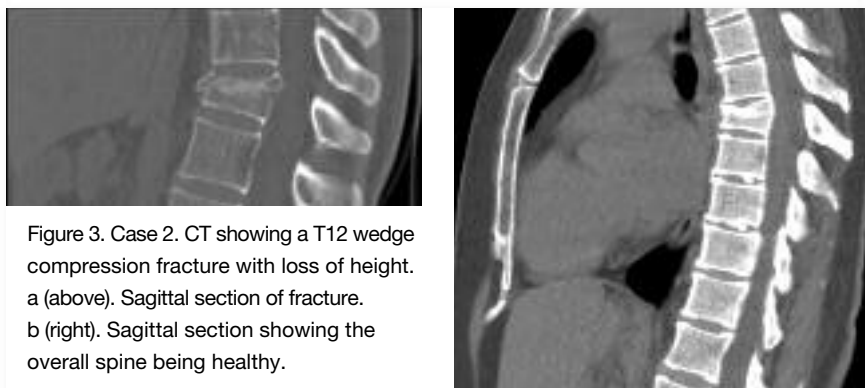
Figure 3. Case 2. CT showing a T12 wedge compression fracture with loss of height. a (above). Sagittal section of fracture. b (right). Sagittal section showing the overall spine being healthy.

On arrival at the emergency department, her pain had decreased to three out of 10. She was given 5 mg oxycodone orally. History and examination were remarkable only in that it was noted by the doctor that the patient did not have midline tenderness. No neurological abnormality was evident. CT of her back showed the typical injury of a stable T12 anterior superior wedge fracture with some 10% loss of vertebral height, with

no involvement of the posterior elements (Figure 3).
